SITE: IDEAL COOPERAGE
DATE: MAY 7-9, 1991
PHOTOS BY: P. DI PASCA (TAT)
DESCRIPTION: FIRST WEEK OF
SITE ACTIVITY

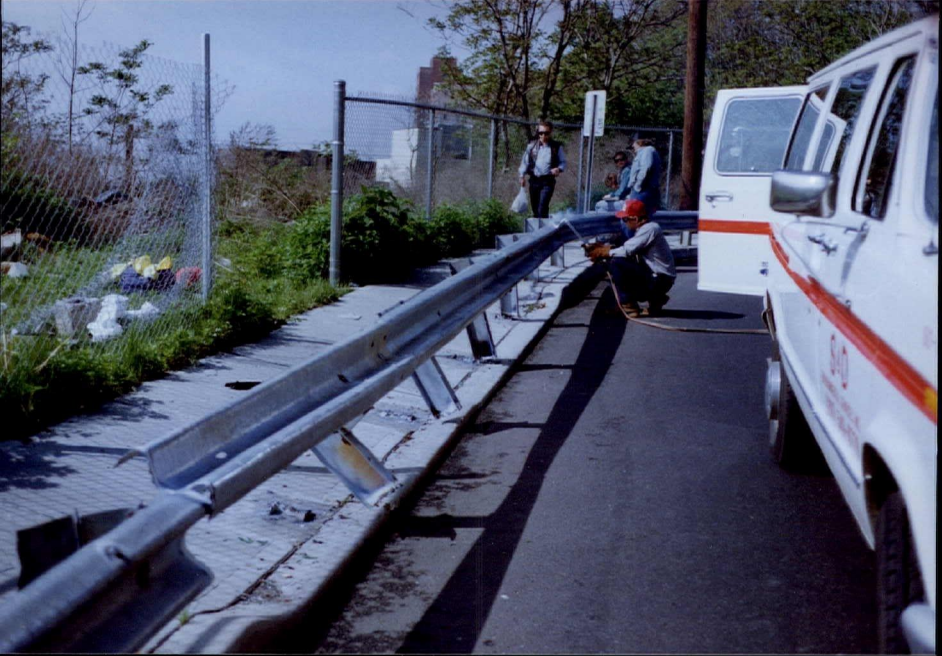
SITE: Ideal Cooperage, Jersey City, NJ
DATE: 05/07/91 PHOTO BY: P. Di Pasca
DESCRIPTION: Removal of guard rail from
entrance to site

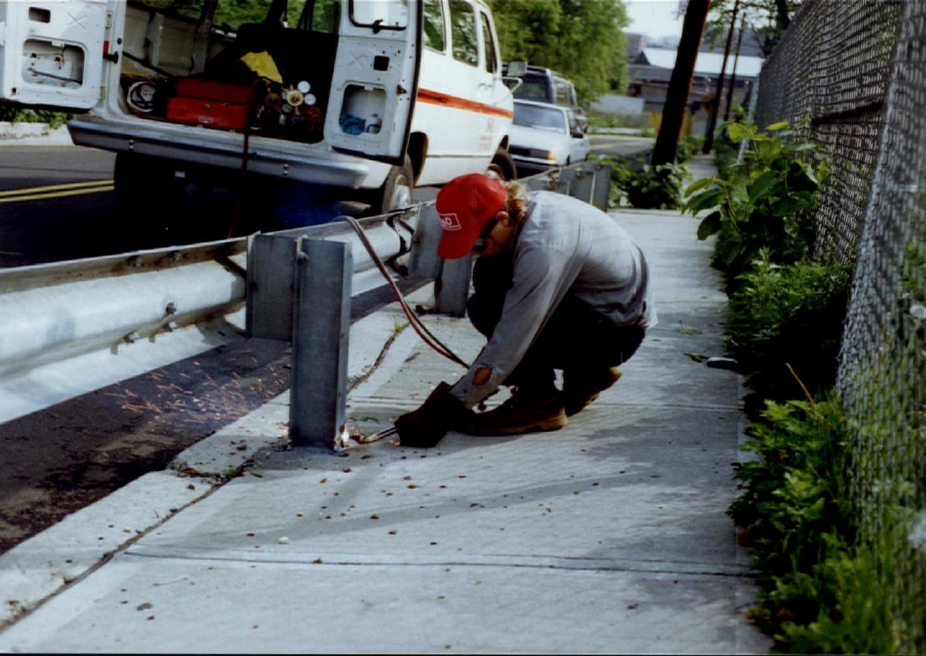
SITE: Ideal Cooperage, Jersey City, NJ
DATE: 05/07/91 PHOTO BY: P. Di Pasca
DESCRIPTION: Removal of guard rail from
entrance to site

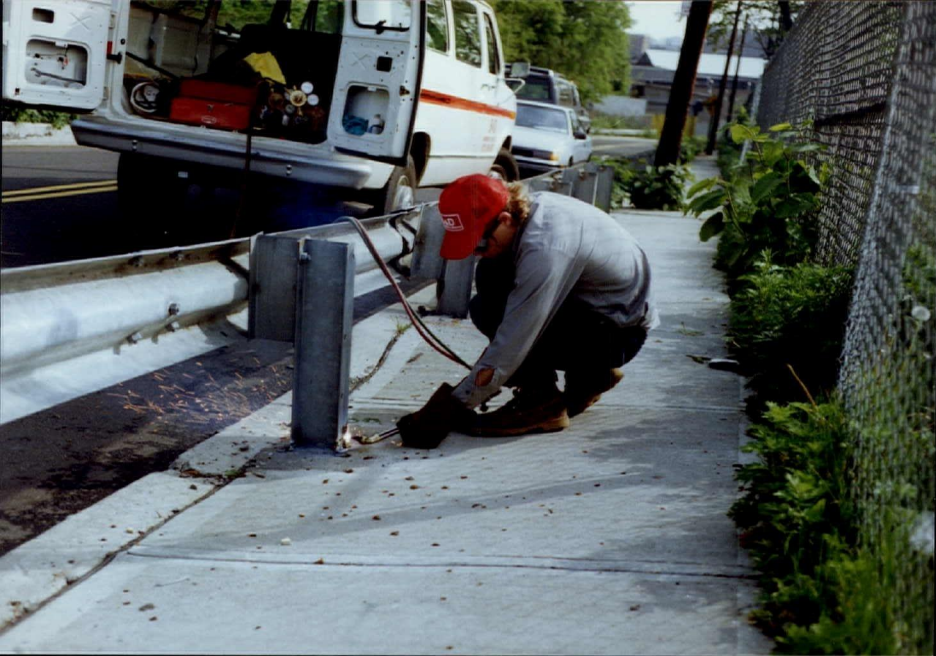
SITE: Ideal Cooperage, Jersey City, NJ
DATE: 05/07/91 PHOTO BY: P. Di Pasca
DESCRIPTION: Removal of guard rail from
entrance to site

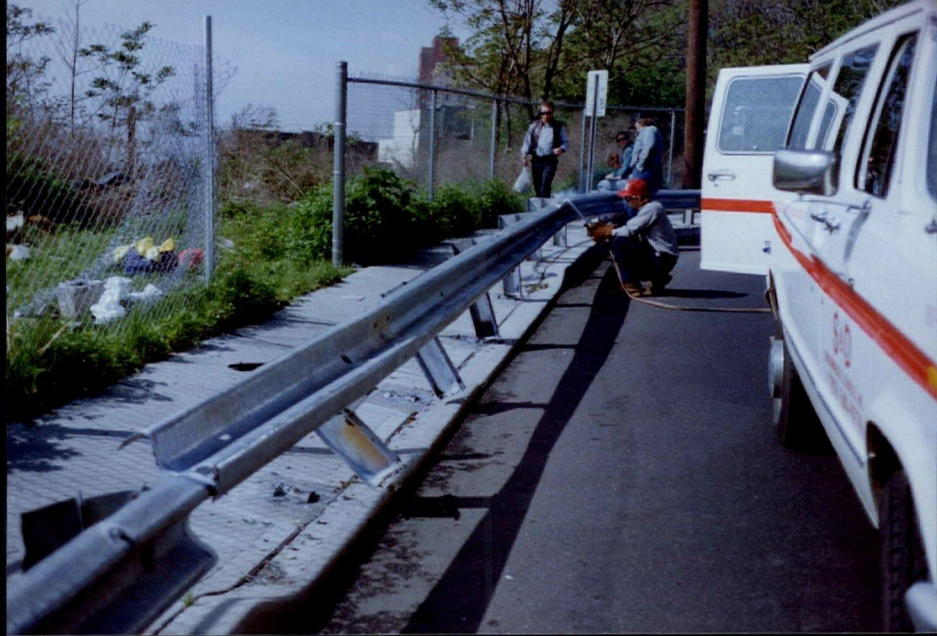
SITE: Ideal Cooperage, Jersey City, NJ
DATE: 05/07/91 PHOTO BY: P. Di Pasca
DESCRIPTION: Removal of guard rail from
entrance to site

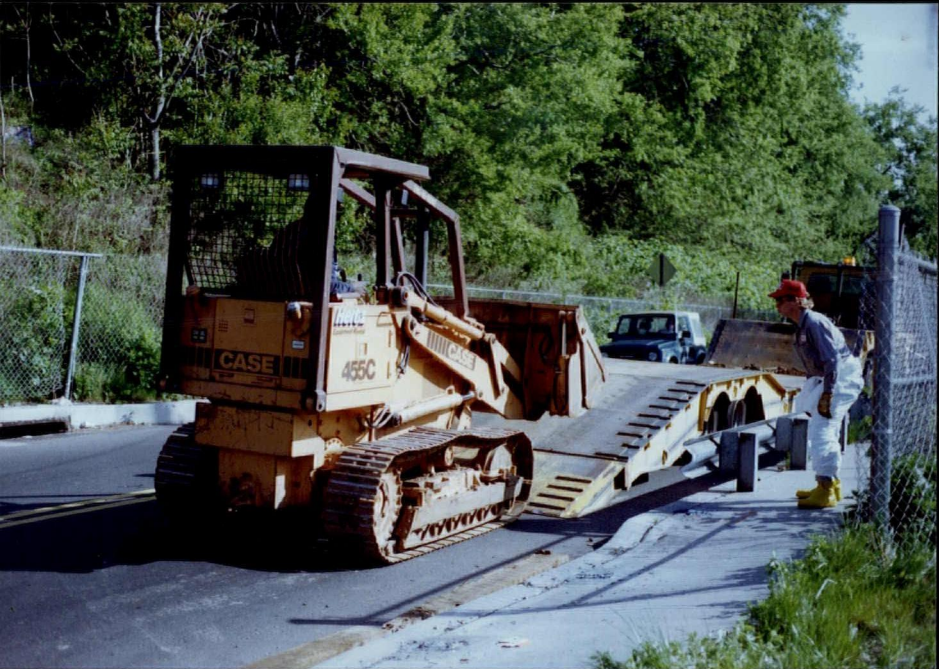
SITE: Ideal Cooperage, Jersey City, NJ
DATE: 05/08/91 PHOTO BY: P. Di Pasca
DESCRIPTION: Delivery of track loader

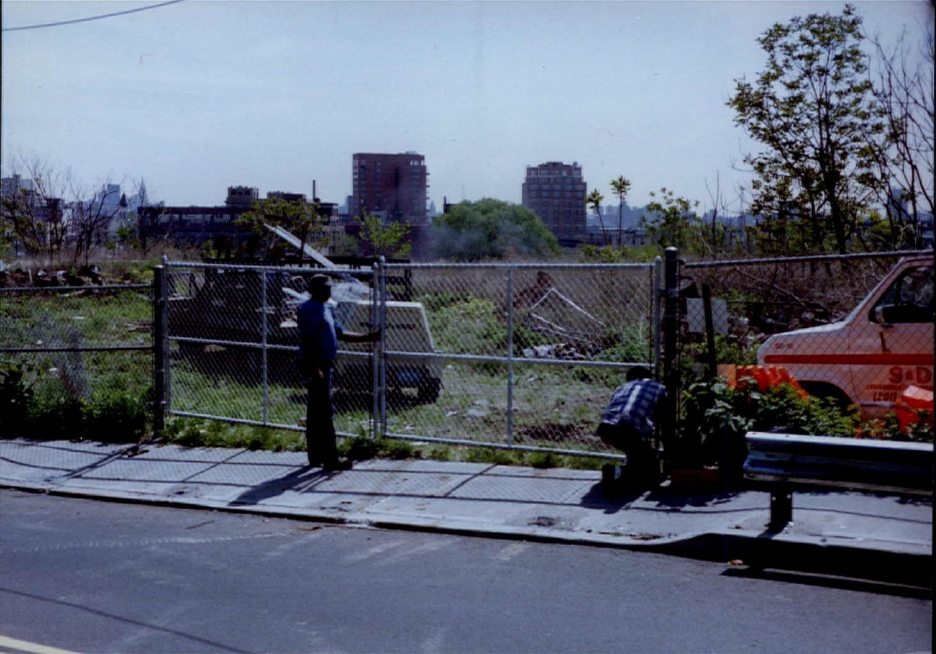
SITE: Ideal Cooperage, Jersey City, NJ
DATE: 05/08/91 PHOTO BY: P. Di Pasca
DESCRIPTION: Installation of new
front gate

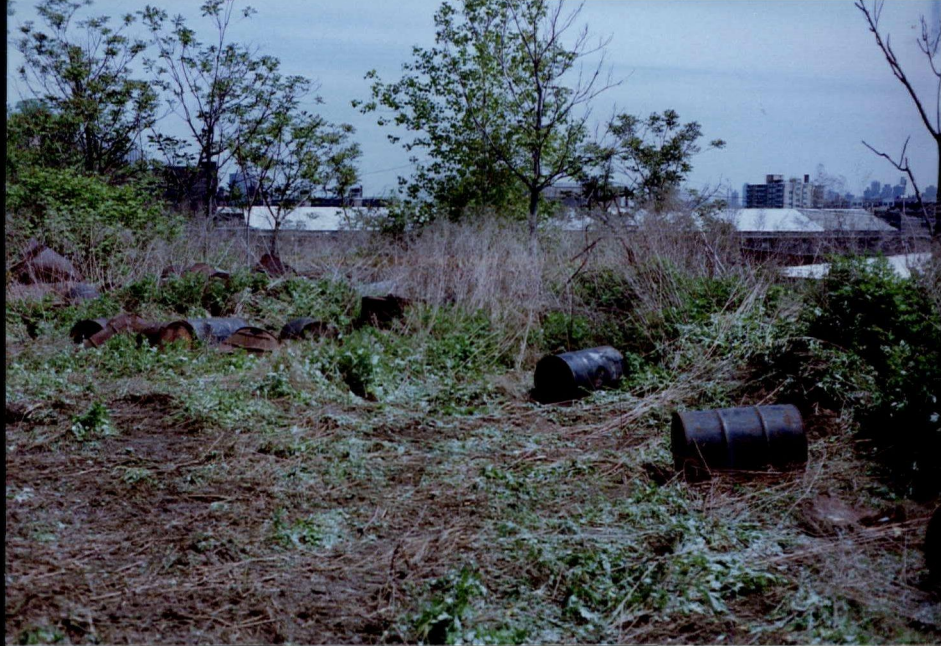
SITE: Ideal Cooperage, Jersey City, NJ
DATE: 05/08/91 PHOTO BY: P. Di Pasca
DESCRIPTION: Initial conditions of site -
north end

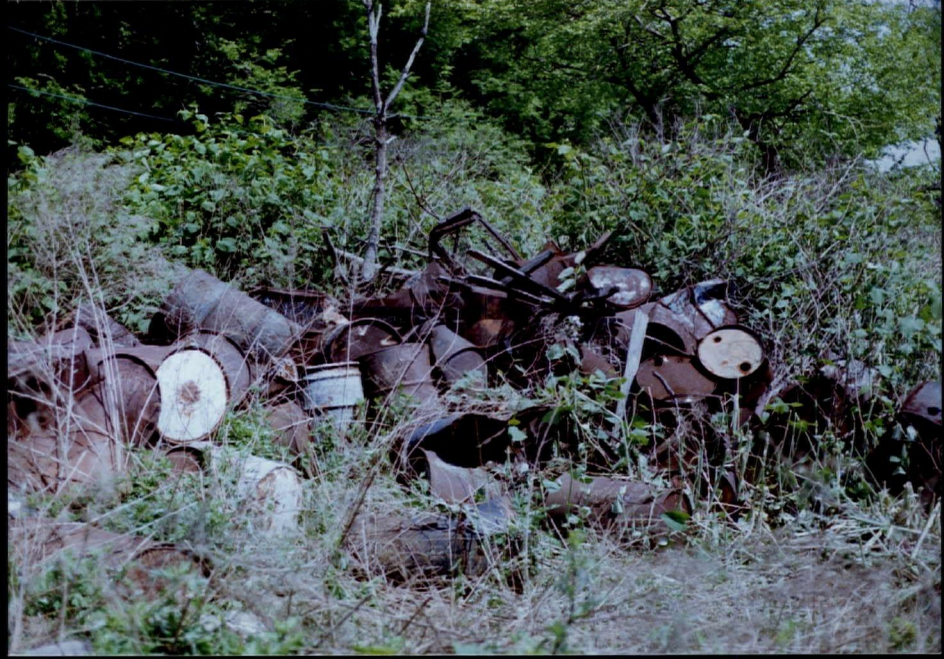
SITE: Ideal Cooperage, Jersey City, NJ
DATE: 05/08/91 PHOTO BY: P. Di Pasca
DESCRIPTION: Initial conditions of site -
west side

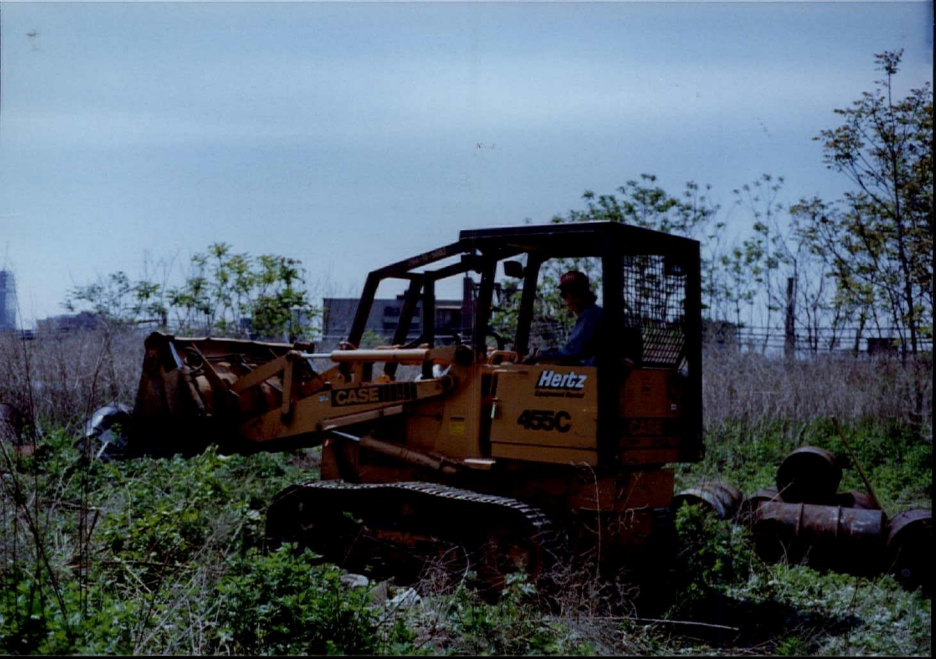
SITE: Ideal Cooperage, Jersey City, NJ
DATE: 05/08/91 PHOTO BY: P. Di Pasca
DESCRIPTION: Track loader used for
clearing of debris and drum
restaging

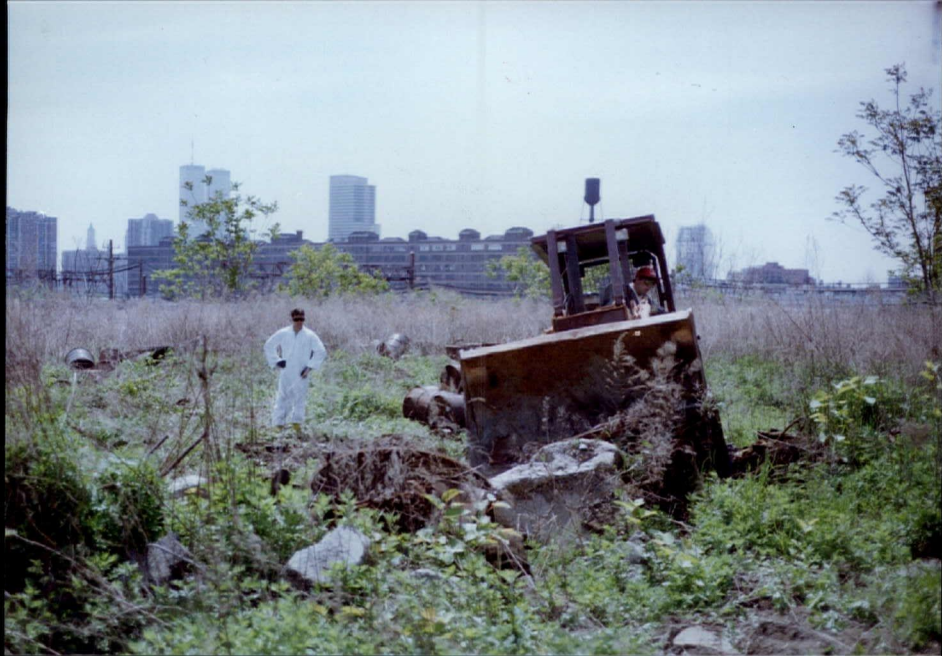
SITE: Ideal Cooperage, Jersey City, NJ
DATE: 05/08/91 PHOTO BY: P. Di Pasca
DESCRIPTION: Clearing of non-hazardous
debris with track loader

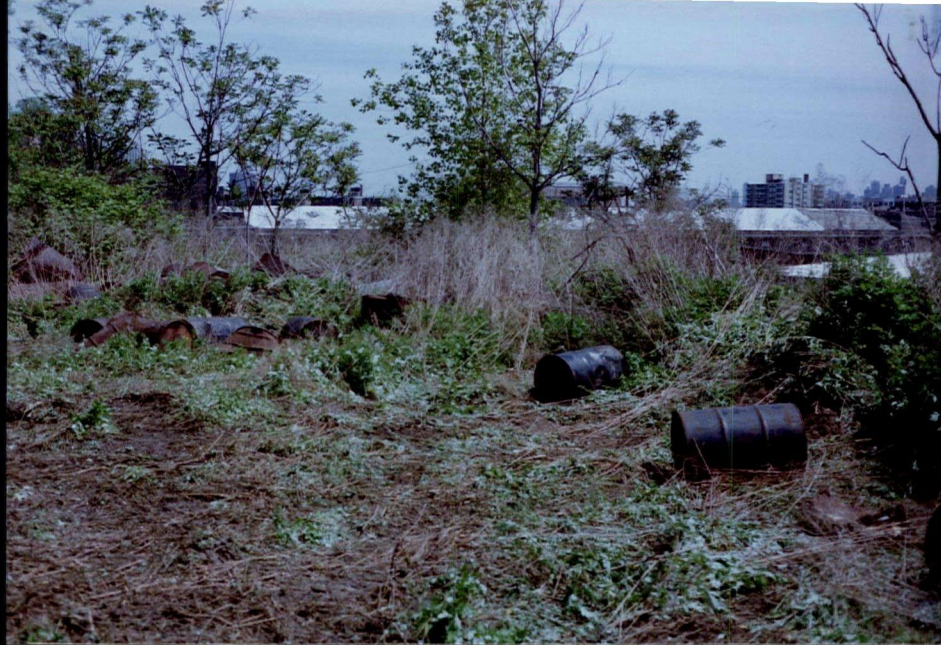
SITE: Ideal Cooperage, Jersey City, NJ
DATE: 05/08/91 PHOTO BY: P. Di Pasca
DESCRIPTION: Initial conditions of site -
north end

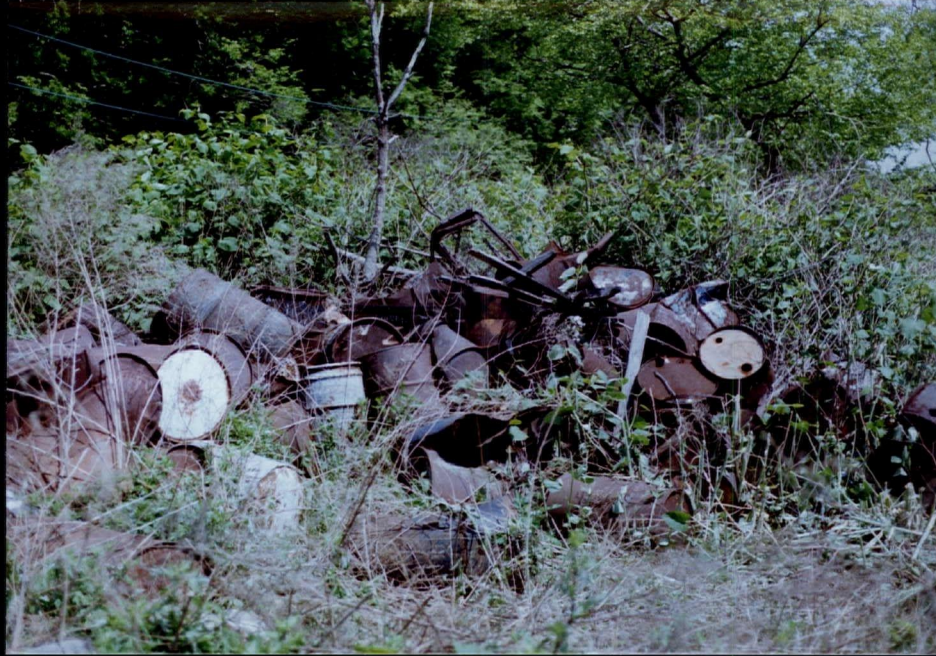
SITE: Ideal Cooperage, Jersey City, NJ
DATE: 05/08/91 PHOTO BY: P. Di Pasca
DESCRIPTION: Initial conditions of site -
west side

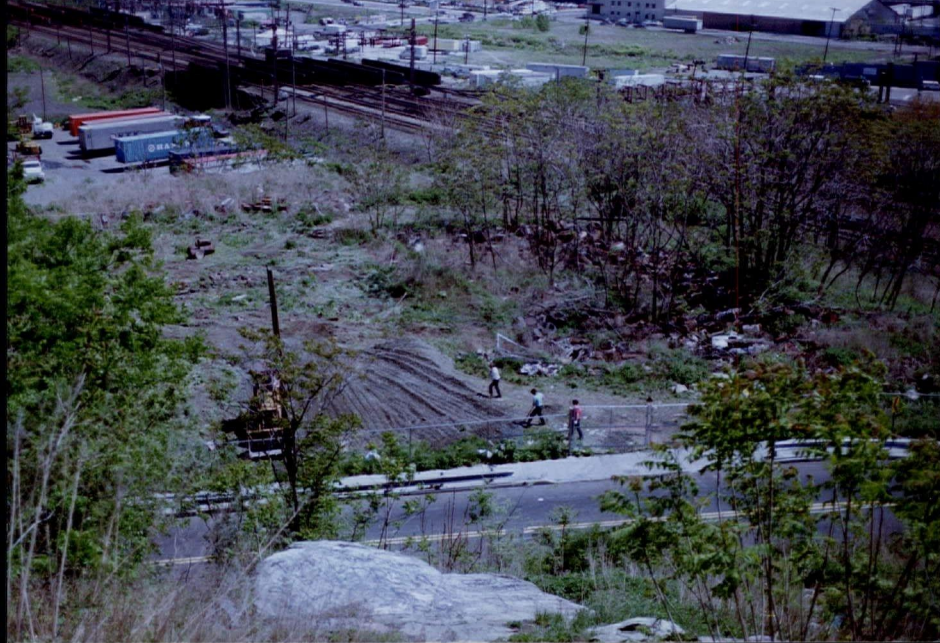
SITE: Ideal Cooperage, Jersey City, NJ
DATE: 05/08/91 PHOTO BY: P. Di Pasca
DESCRIPTION: Aerial view of initial
conditions - south end of site

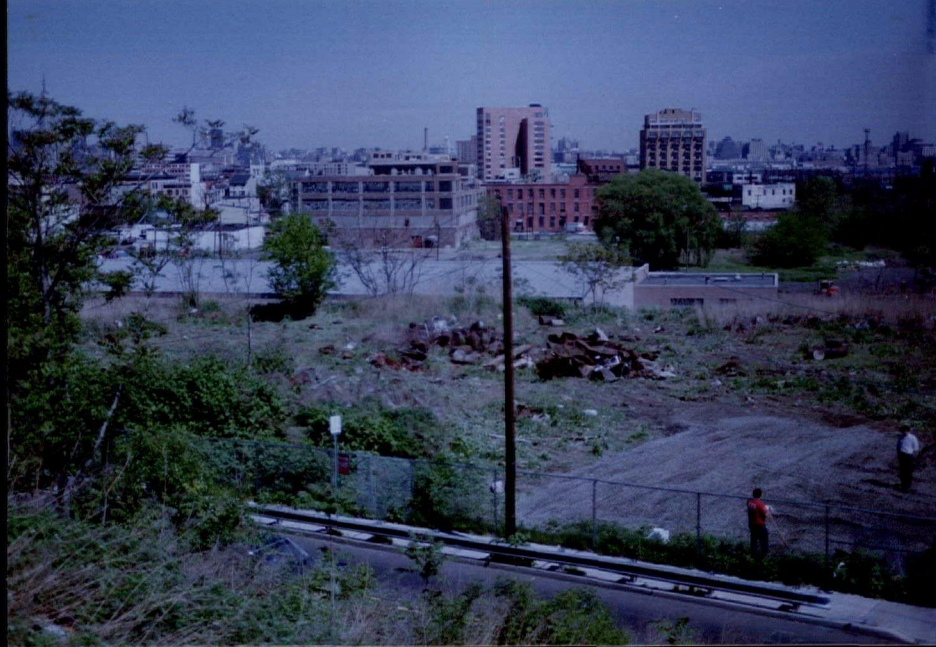
SITE: Ideal Cooperage, Jersey City, NJ
DATE: 05/08/91 PHOTO BY: P. Di Pasca
DESCRIPTION: Aerial view of initial
conditions - north end of site

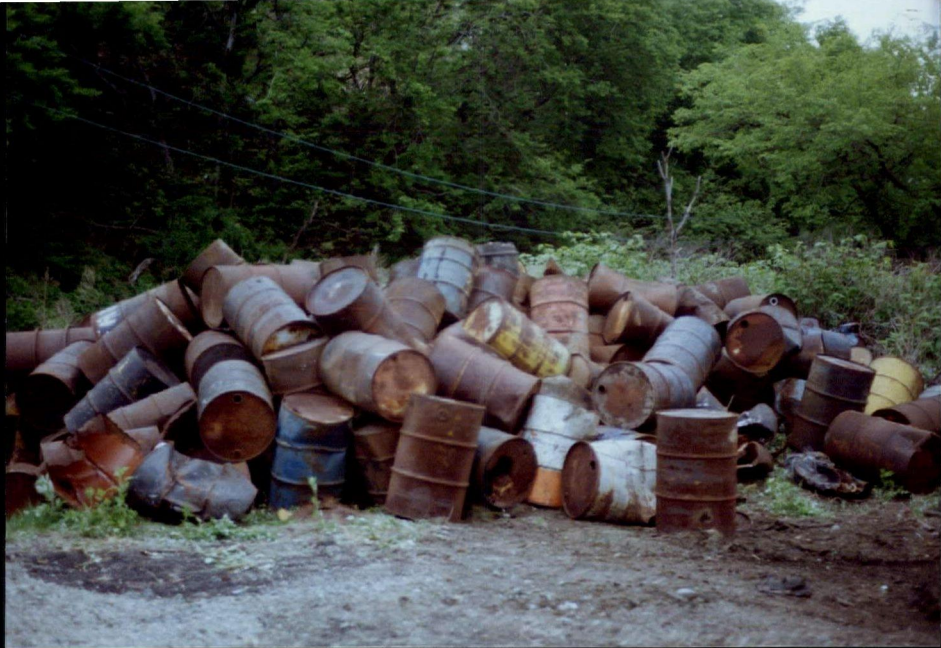
SITE: Ideal Cooperage, Jersey City, NJ
DATE: 05/08/91 PHOTO BY: P. Di Pasca
DESCRIPTION: Pile of empty drums before
restaging into rows

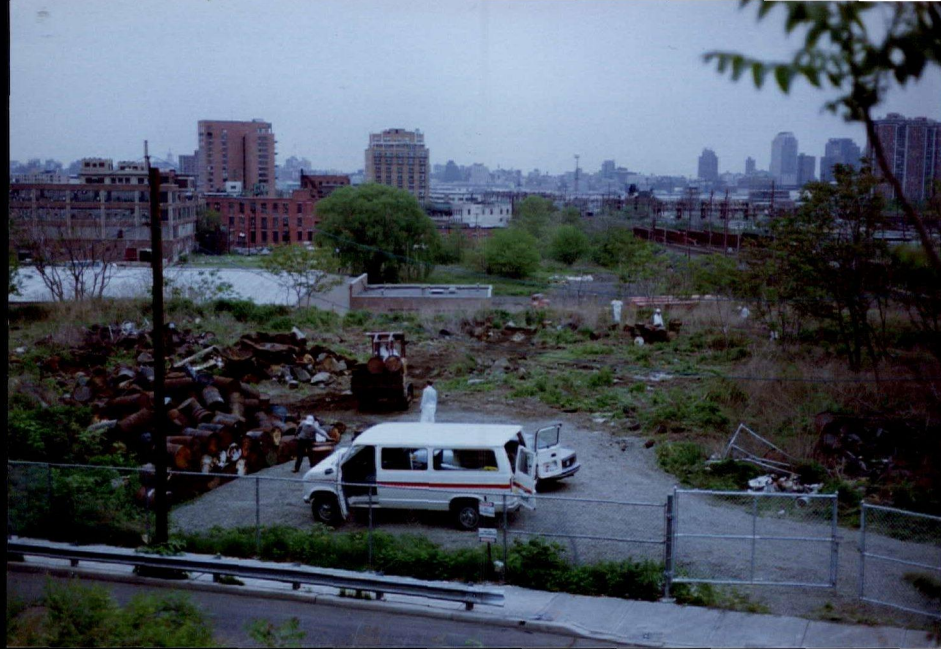
SITE: Ideal Cooperage, Jersey City, NJ
DATE: 05/08/91 PHOTO BY: P. Di Pasca
DESCRIPTION: Aerial view of central
section of site during
empty drum restaging

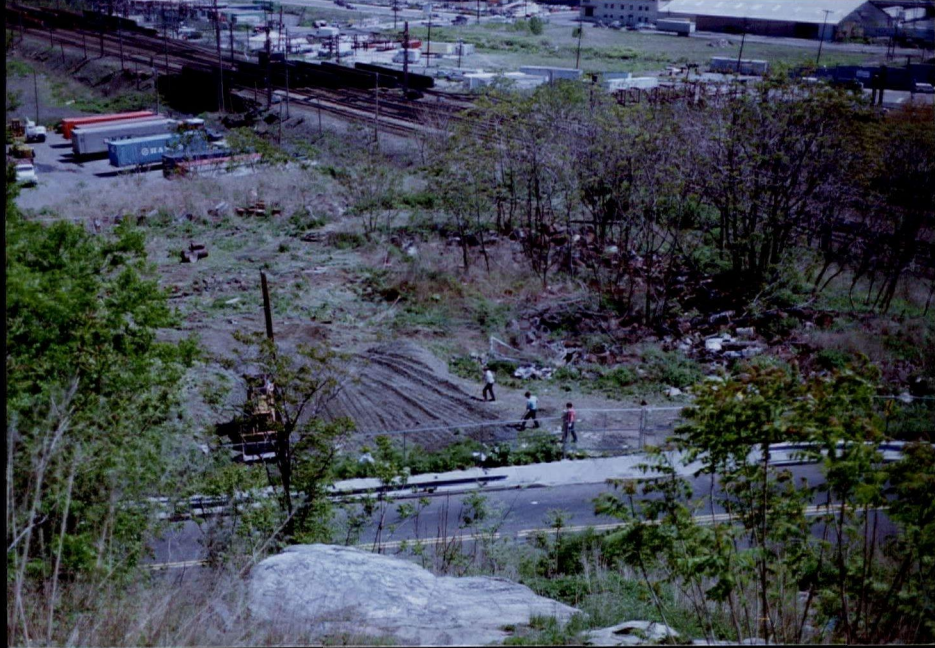
SITE: Ideal Cooperage, Jersey City, NJ
DATE: 05/08/91 PHOTO BY: P. Di Pasca
DESCRIPTION: Aerial view of initial
conditions - south end of site

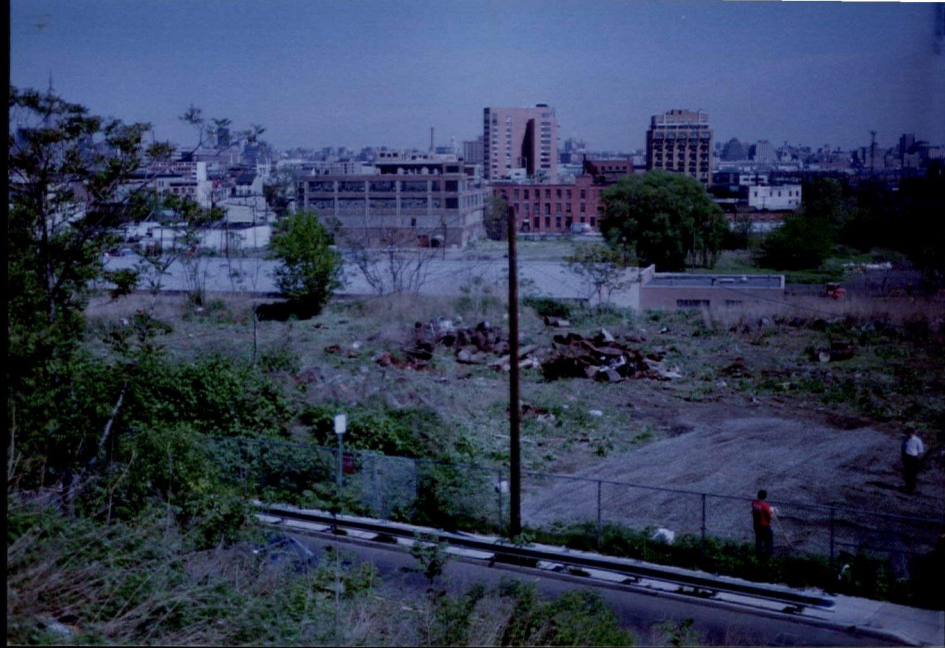
DESCRIPTION: Aerial view of initial
conditions - north end of site

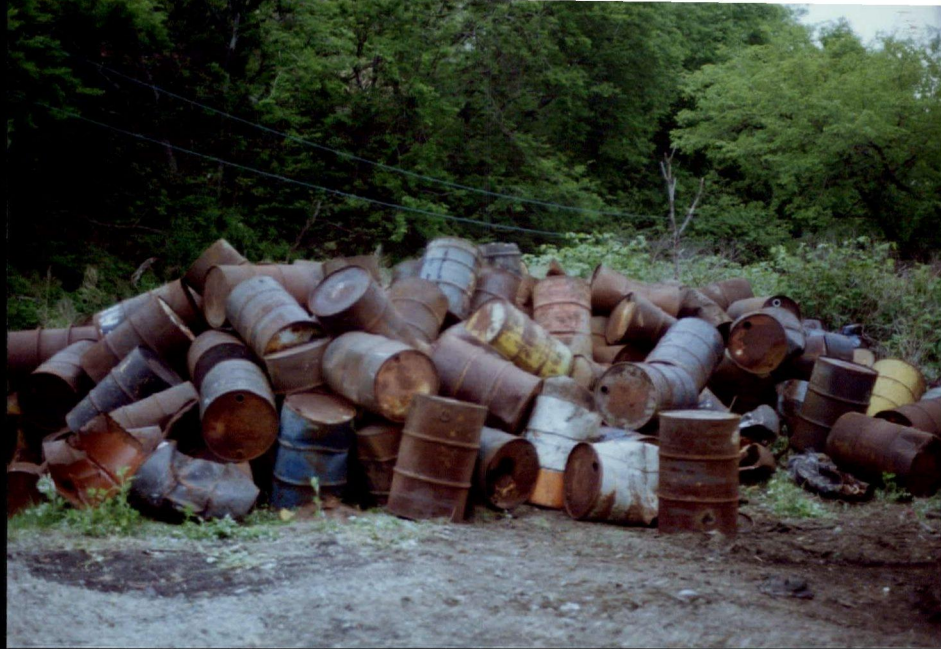
SITE: Ideal Cooperage, Jersey City, NJ
DATE: 05/08/91 PHOTO BY: P. Di Pasca
DESCRIPTION: Pile of empty drums before
restaging into rows

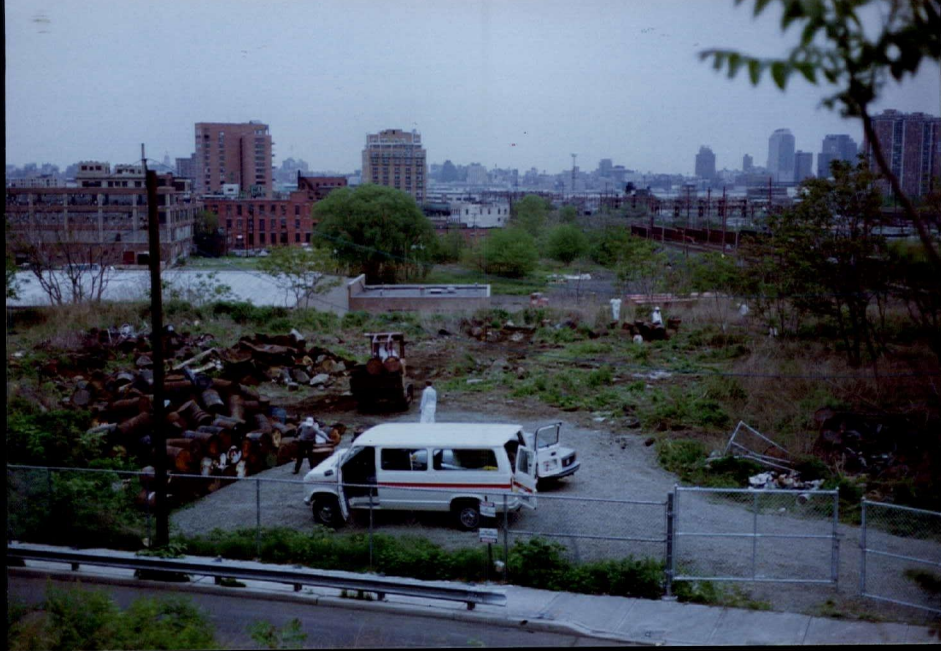
SITE: Ideal Cooperage, Jersey City, NJ
DATE: 05/08/91 PHOTO BY: P. Di Pasca
DESCRIPTION: Aerial view of central
section of site during
empty drum restaging

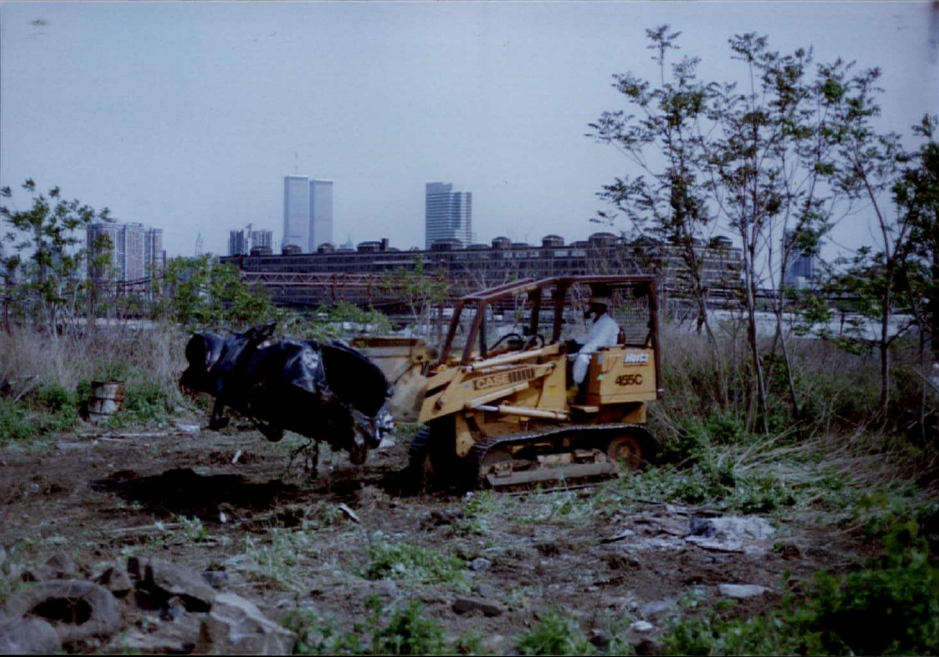
SITE: Ideal Cooperage, Jersey City, NJ
DATE: 05/09/91 PHOTO BY: P. Di Pasca
DESCRIPTION: Clearing of non-hazardous
debris with track loader

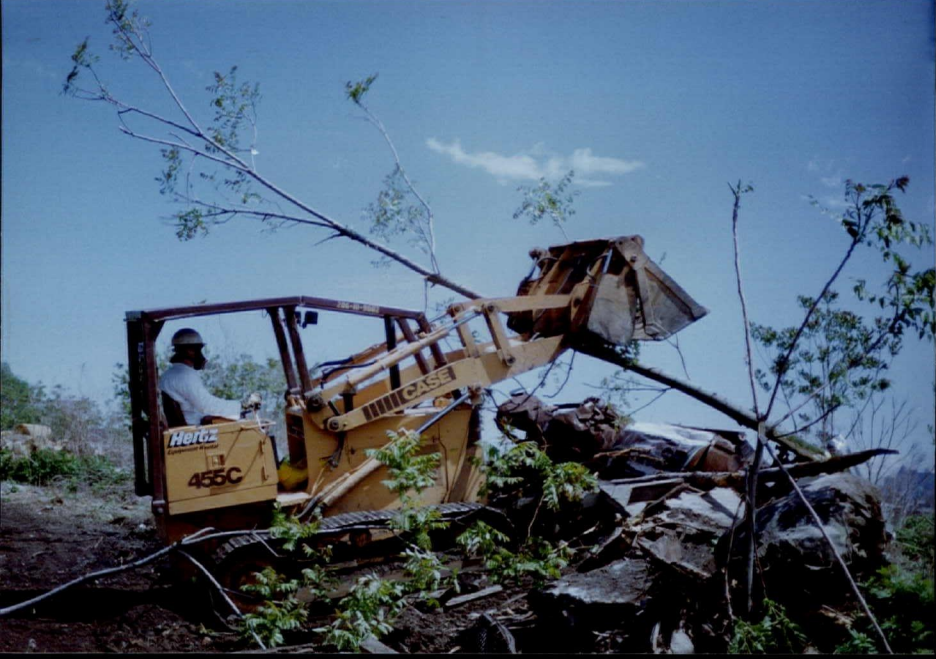
SITE: Ideal Cooperage, Jersey City, NJ
DATE: 05/09/91 PHOTO BY: P. Di Pasca
DESCRIPTION: Clearing of non-hazardous
debris with track loader

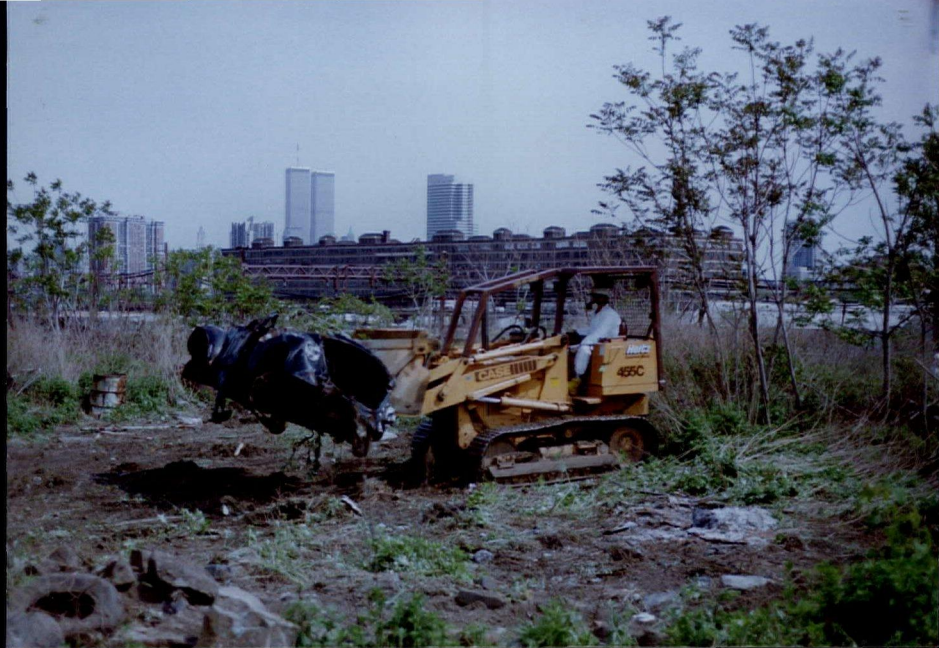
SITE: Ideal Cooperage, Jersey City, NJ
DATE: 05/09/91 PHOTO BY: P. Di Pasca
DESCRIPTION: Clearing of non-hazardous
debris with track loader

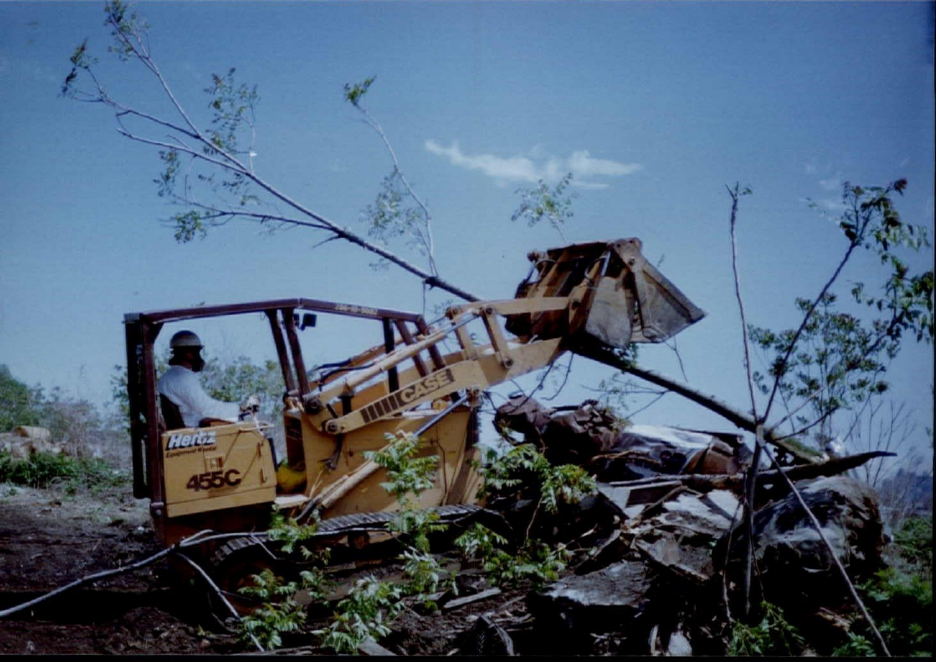
SITE: Ideal Cooperage, Jersey City, NJ
DATE: 05/09/91 PHOTO BY: P. Di Pasca
DESCRIPTION: Clearing of non-hazardous
debris with track loader
